FEDERAL EMERGENCY MANAGEMENT AGENCY

# *Above the Flood:* **ELEVATING YOUR FLOODPRONE HOUSE**

Almost all single-family homes in Miami-Dade County are constructed with reinforced masonry block walls on a **slab-on-grade** foundation. Houses of this type are the most difficult to elevate for flood protection. This publication describes how homeowners in Miami-Dade County elevated their damaged slab-on-grade masonry houses following the devastating effects of Hurricane Andrew.

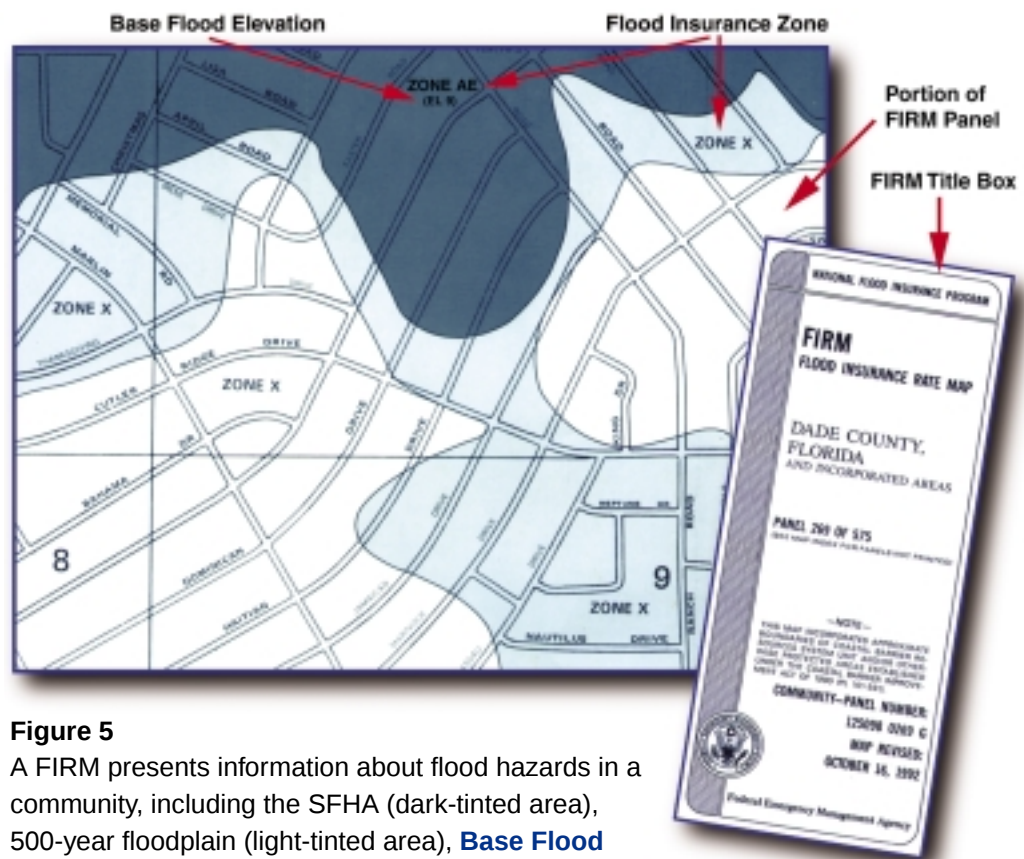
**Figure 5**

A FIRM presents information about flood hazards in a community, including the SFHA (dark-tinted area), 500-year floodplain (light-tinted area), **Base Flood Elevations**, (BFEs) (number in parentheses), and flood insurance zones (AE and X in this example).

Note that the SFHA in the example in Figure 5 is designated Zone AE. This zone is only one of several applied to SFHAs under the NFIP, including V, VE, V1-V30, A, AE, A1-A30, AO, and AH. These zones indicate differences in the types and severity of flood hazards in SFHAs. For the purposes of this publication, it is sufficient to focus on the basic differences between the two main types of SFHA zones—V zones and A zones. The distinction is important because regulatory requirements associated with V zones and A zones differ significantly. As explained later in this chapter, these requirements affect the types of building elevation techniques that may be used under the NFIP.

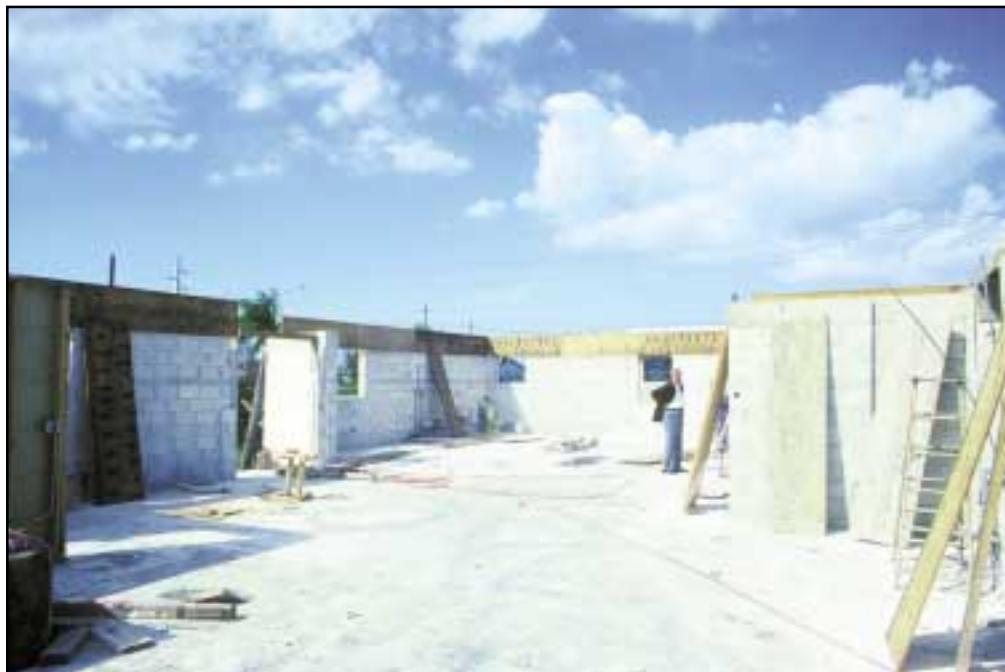
**Figure 40**

After the roof was removed and the storm-damaged interior gutted, the walls of the house were extended upward and a new bond beam added at the top.

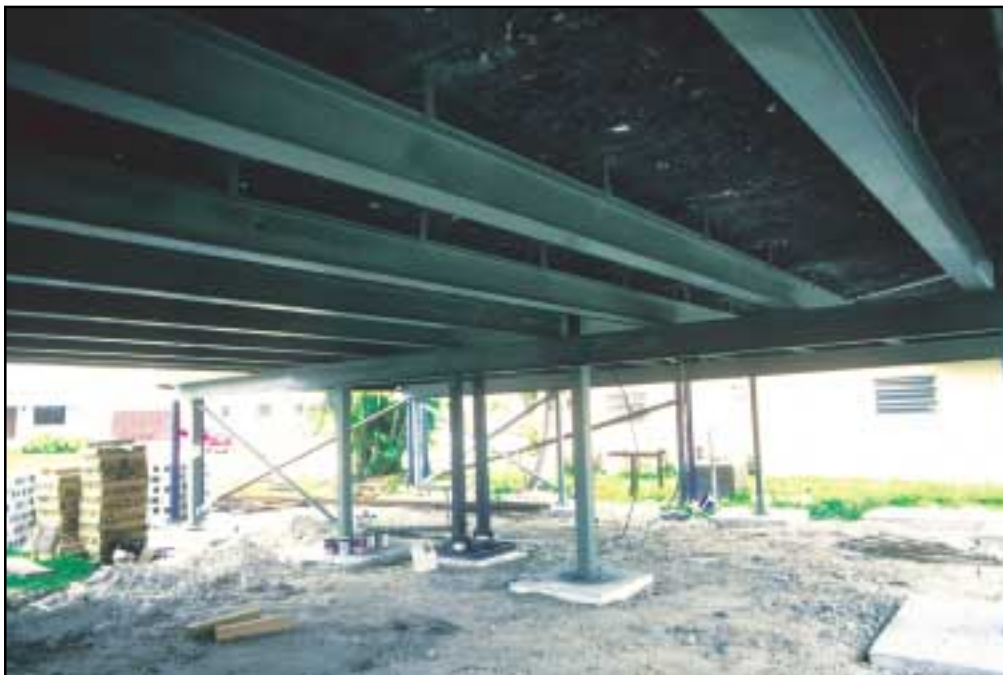
**Figure 82**

While the jacks and beams supported the house, new steel foundation members were installed below.
